RARITAN RIVER BASIN
McGELLAIRDS BROOK, MONMOUTH COUNTY
NEW JERSEY

LAKE TOPANEMUS DAM
NJ 00219

PHASE 1 INSPECTION REPORT
NATIONAL DAM SAFETY PROGRAM

August, 1979 09 19 024

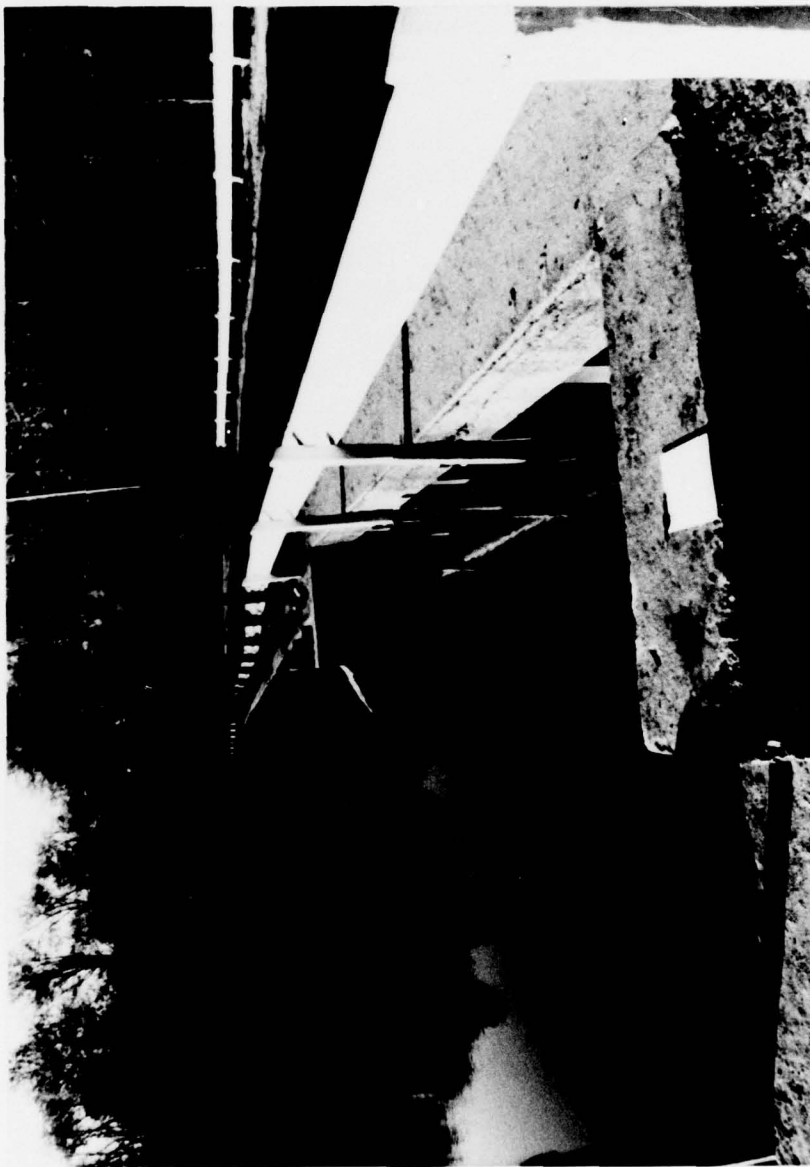
Lake Topanemus Dam
View of upstream face of the dam.

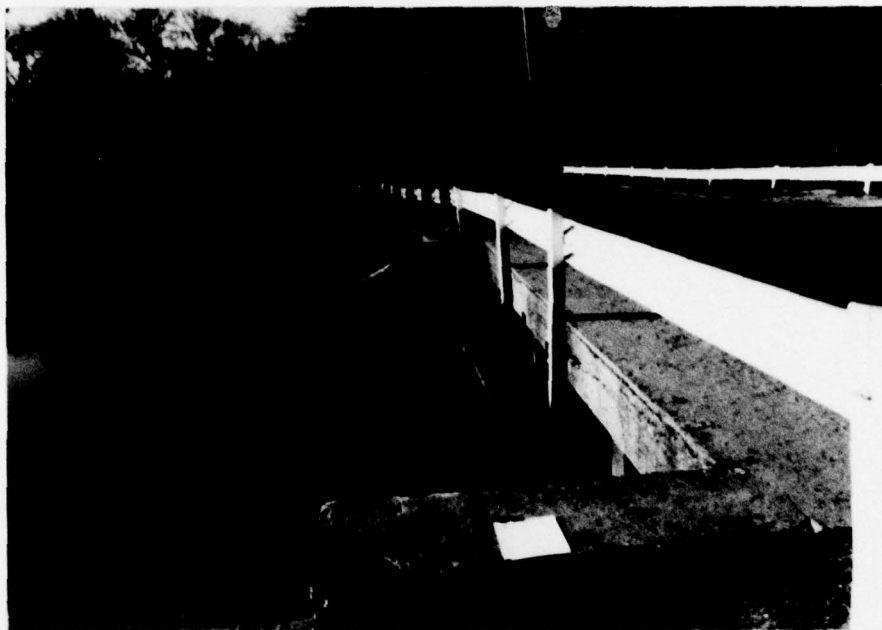
Photo No. 1 - Overall view of dam from upstream. The spillway and bridge structure are in the foreground. Note the key shafts for the low level outlet valves projecting from the water.

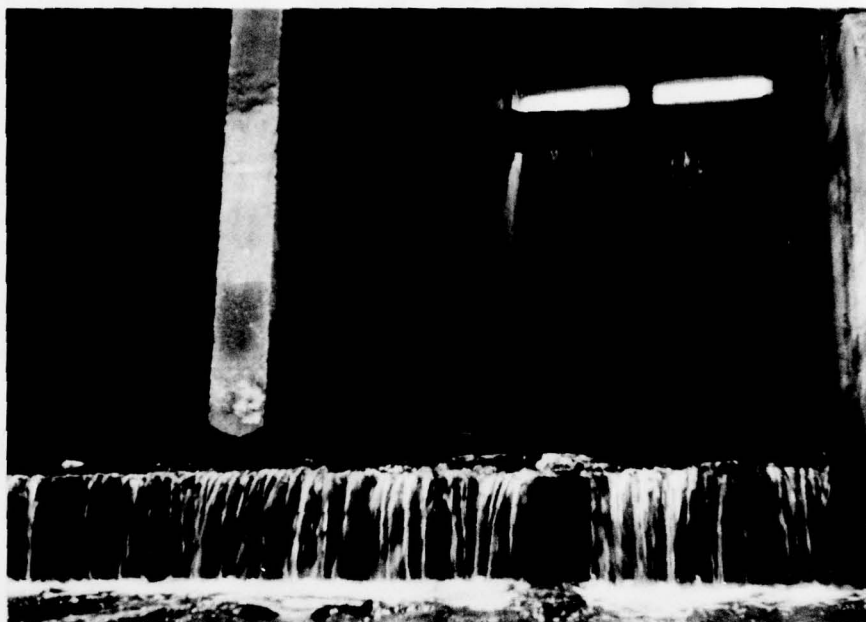
Erosion and spalling of the concrete at the base of the bridge piers and abutments is extensive. In places the piers have been eroded right through. Surface spalling of the concrete is up to 6" deep in small local areas. Between the old and the new construction, joints have opened due to foundation settlement, but this condition appears to have stabilized. The cracks thus formed are no larger than $\frac{1}{4}$ inch across. The piers and abutments have been cut out in two places to allow a water main and a bank of cable conduits to pass through.

Photo No. 3 - View of middle outlet channel and spillway. Note the deteriorated concrete at the foot of the bridge pier.

(3) Restore the areas of eroded and spalled concrete and repair cracks to arrest further deterioration.

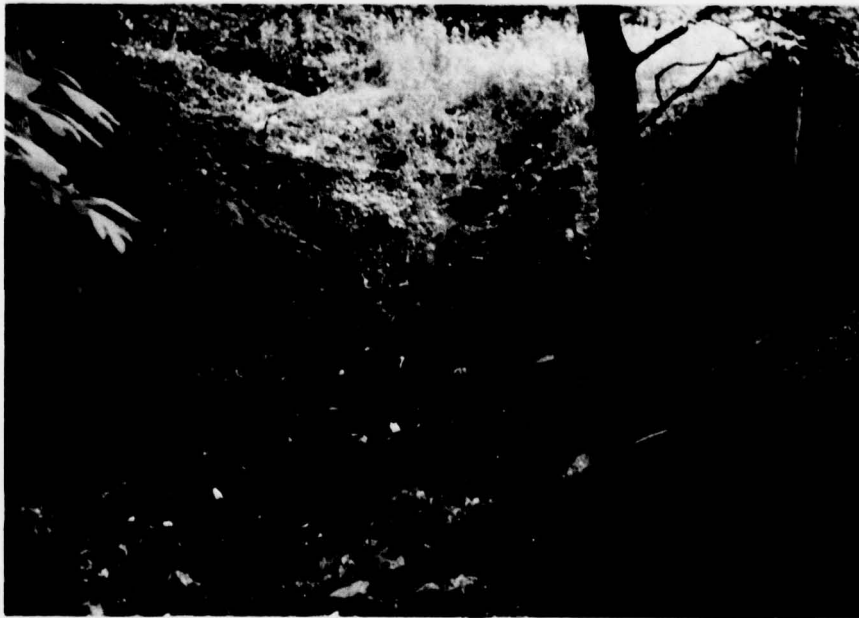
STAFF GAGE AND RECORDER	N/A	
DRAINS	Two twelve inch diameter road drains discharge onto the downstream embankment face, and have caused some local erosion.	Restore the eroded material and provide surface protection under drain outfall.

Photo No. 8 - View of downstream embankment face to the right of the spillway. Note the loss of material due to erosion under the road drain outfall.

(1) Replace embankment material that has been lost from the downstream face, particularly adjacent to the abutments of the bridge/spillway.

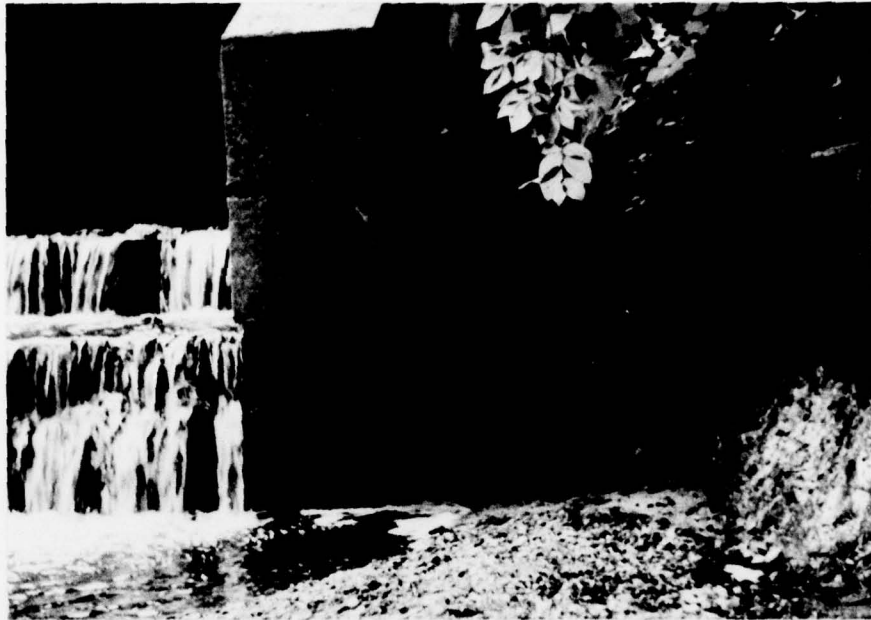
The spillway exhibits no visible evidence of slide failure. Settlement of the newer portion is evidenced by opening of construction joints, but this condition appears to have stabilized. Undermining of the toe of the left abutment has taken place, and stub wingwalls have settled and cracked away from the abutments.

Photo No. 9 - Detail showing loss of material and seepage around the toe of the left abutment.

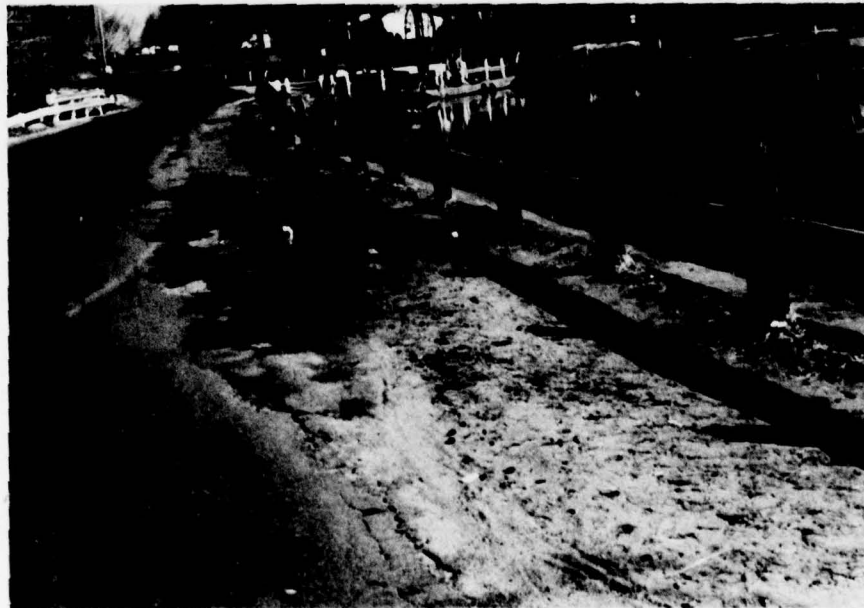
Minor settlement was noted on parts of the downstream side of the road, and surface cracks in the road were found. It is not felt that these originated from any general movement of the embankment but rather from the affects of freezing and consolidation. No cracking or sloughing was seen on the downstream face. It was not possible to determine visually if the embankment has been built with a corewall. No evidence of burrowing by animals was found.

Photo No. 10 - Overall view roadway looking to the right. Cracking in the surface of the road appears to be due to freezing.

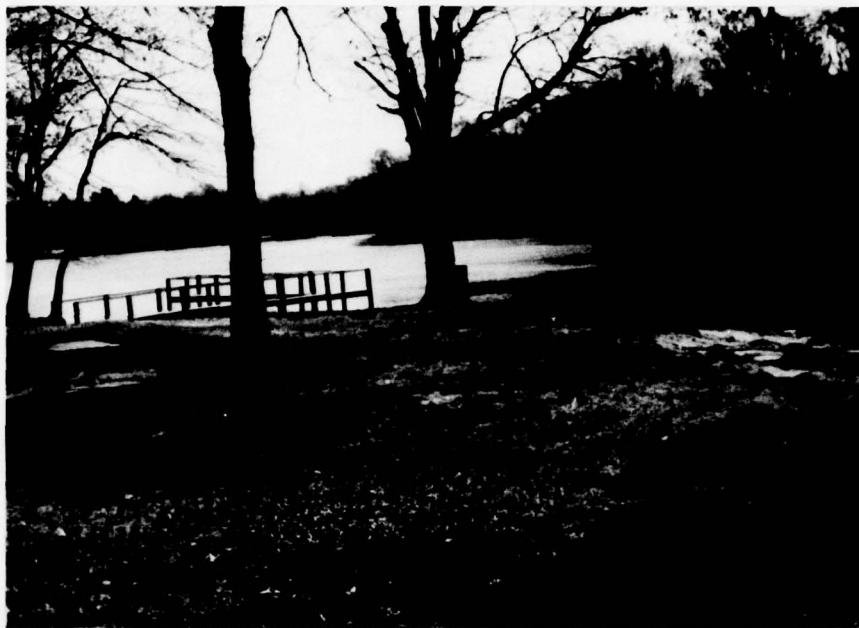
Photo No. 11 - View of Lake Topanemus looking upstream from the right shore. Note moderate slopes.
